DEPARTMENT OF ECOLOGY

M E M O R A N D U M May 22, 1985

The Effects of the Purdy Landfill on Fecal Coliform Levels in Nearby

Streams: A Minter/Burley/Purdy Watersheds Supplementary Study

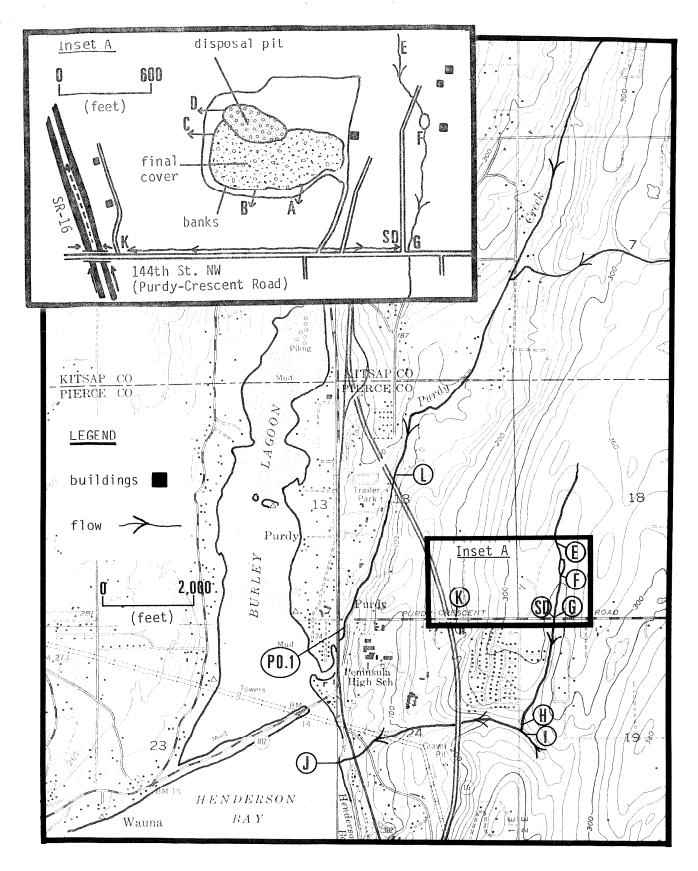
Figure 1. Purdy Landfill and Burley Lagoon showing water sampling sites on March 26, 1985.

Samples taken near the landfill disposal pit (sites C and D; Figure 1, inset A) were an order of magnitude higher than samples from the "final cover" terrace (samples A and B, inset A). The reason may be due in part to the presence of thousands of gulls and crows that stay close to the margins of the disposal pit. Few birds were seen on the remaining "final cover" area. The birds likely feed on the solid waste. There is little evidence that the waste is routinely covered with earth, which is the usual practice in landfill management.

The drainage from the roadside ditch at site K carried the highest concentrations of fecal coliforms (FC) encountered during the survey excluding the landfill itself. The FC load at Site K was nearly 14 times greater than the load carried into the eastern creek from the same ditch (Site SD). The conductivity at Site K was over twice as high as that at Site SD (34 and 13 umhos/cm, respectively). According to the contours on Figure 1, Site K lies about 100 feet lower in elevation than the landfill disposal pit. Site SD lies at the same or slightly higher elevation than the pit. There were no grazing animals, buildings, or other potential FC sources visible along 144th Street NW between Sites K and SD. We located no ditches, ravines, or creeks carrying runoff from the landfill to the roadside ditch over the ground. These facts suggest that ground-water movement from the landfill may be finding its way into the drainage ditch. The presence of a subsurface hardpan may facilitate this movement. The ultimate fate of this drainage is Purdy Creek and Burley Lagoon through the SR 16 storm drain.
